Lower Makefield Township

Baseline Swimming Pool Feasibility Study

*Baseline Feasibility Study
Final Report*

**LOWER MAKEFIELD TOWNSHIP COMMUNITY POOL COMPLEX
BASELINE RENOVATION FEASIBILITY STUDY**

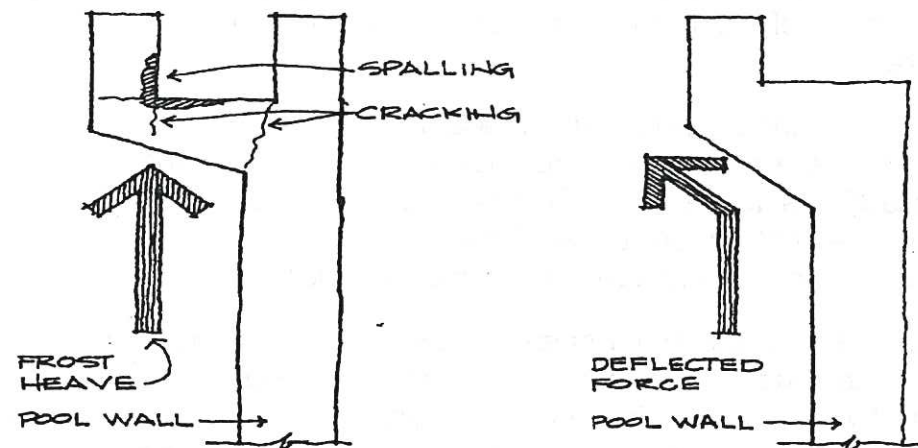
GUTTER AS CONSTRUCTED:

The pool manager, Mr. Brad Sharp indicated that water loss in the main 50-meter pool is constant and if left unattended will stop at the base of the bullnose coping. This would indicate that the water loss is in the pool overflow gutter system. In our professional opinion the major reason for the water loss in the pool gutter is the design and profile of the pool beam. RCI has historically designed pool gutter/beams with a bottom slope of the beam structure of approximately 24 degrees or less.

Normally this slope is maintained at a 45 degree or steeper angle. This greater slope allows the rear of the pool wall to deflect upward soil pressures or frost heave. The "flatter" slope allows frost to affect the top of the wall with increased pressure and associated movement causing cracks at the joint of the vertical wall and pool beam. This cracking permits water to migrate from the gutter return trough to the earth behind the pool wall. With the water loss stopping at the base of the coping, it would clearly indicate that water loss is within the overflow gutter and not in any of the underground piping.

Over time the constant migration of chlorinated water will create deterioration of reinforcing steel and the detail will ultimately fail. We believe it is this situation that has caused the failure of the rear of the concrete gutter at the main and possibly the intermediate pools. Without significant restorative work, this condition will continue to deteriorate and cause further water loss problems.

3. The installation of the stainless steel gutter system will eliminate the current problem of water loss through the existing concrete gutter trough and underground piping. The stainless steel gutter is not adversely effected by the effects of winter freeze/thaw conditions further reducing ongoing maintenance.
